Lexmark E210

Remanufacturing Instructions

Oasis Imaging Products, Inc. Technical Support: (888) 627-6555

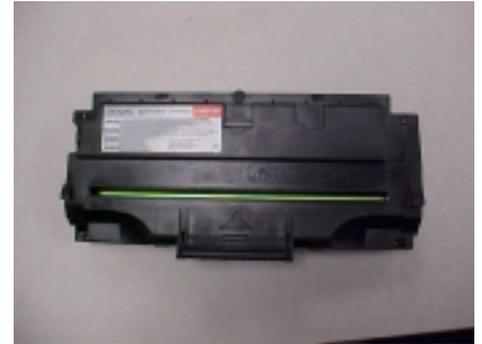
1. With end-clippers cut and remove the small plastic wall surrounding the center locking screw. Using the needle-nose pliers remove the screw and replace it with a #2 self-tapping screw before re-assembly (Fig 1).
2. Remove the other four screw from the top of the cartridge (Fig 2).

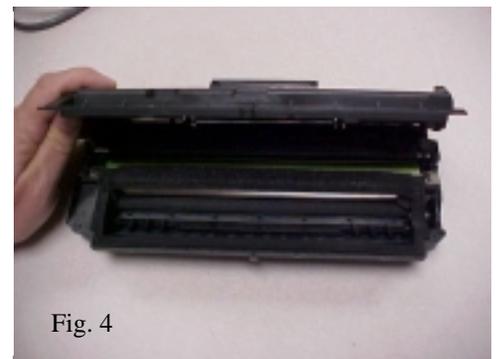
5. Vacuum out all remaining toner from the toner hopper, sponge delivery roller and cartridge interior (Fig 5).
6. Remove the three screws that hold the gear side endplate in place, and then remove the end plate (Fig 6).

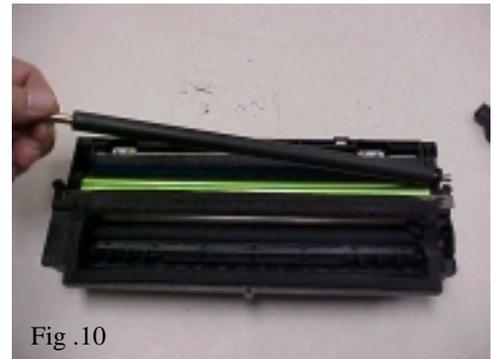
11. Remove the two screws that hold the foam PCR cleaner in place. **CAUTION:** there is a thin piece of urethane that acts as a wiperblade attached to the underside of the cleaning bar, do not damage this component when removing the cleaning bar.
 12. Remove the opc drum from the large helical gear end.
